SUBJECT Chemical Test

CLIENT NAME Husk's Renewable Material Technology Co., LTD

RESULT SUMMARY Melamine

Sample Name: Rice Husks Fiber products, Brown color, surface is rough

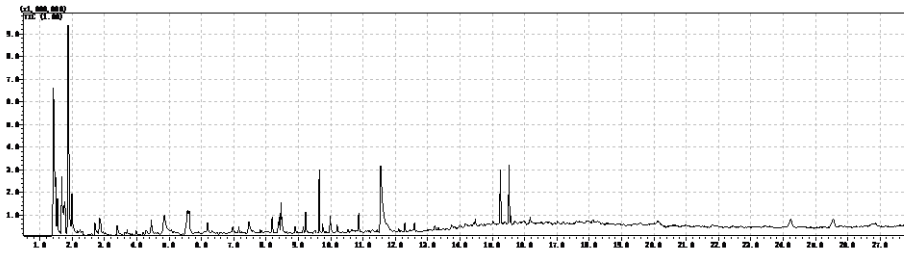
Figure 1 The Py-GCMS spectrum of the sample

Figure 1 is the Py-GCMS spectrum of the sample, melamine is not detected.

Test Item(s)	Result(s) [%]
Melamine	ND
